Northampton Recreational Facilities Maintenance Report City of Northampton, MA

TO: Donna LaScaleia, Director of Public Works
FROM: Ryan Morrison PE, Project Manager, Tighe & Bond,
Zach Chornyak PE, Senior Project Manager, Tighe & Bond
DATE: July 2024

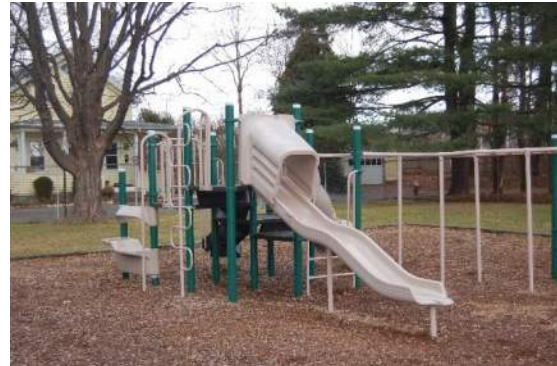
Photo 2: Primary Play Structure

- The primary play structure is in good condition, fall zones appear to be adequate.
- The 2-bay tot swing apparatus is in poor condition with an exposed foundation that creates a potential hazard.
- The four swings are in fair condition. The apparatus is old and shows signs of degradation.
- The roller/climber is in good condition
- The wood fiber surface is very wet, indicating poor drainage. This condition leads to shorter than optimal life of the wood fiber, unevenness of the surface and potential subsidence of the resilient surface due to rotting of the wood fiber.

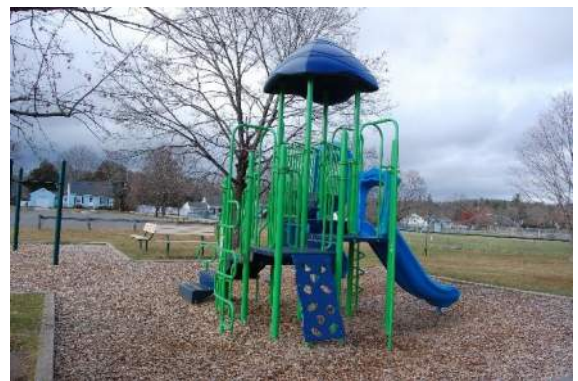
Photo 4: View of Primary Play Structure

- Modern play structure is in good condition
- Fall zone protection appears to be adequate.
- 2 – tot swings and 2-standard swings. One standard swing is missing,

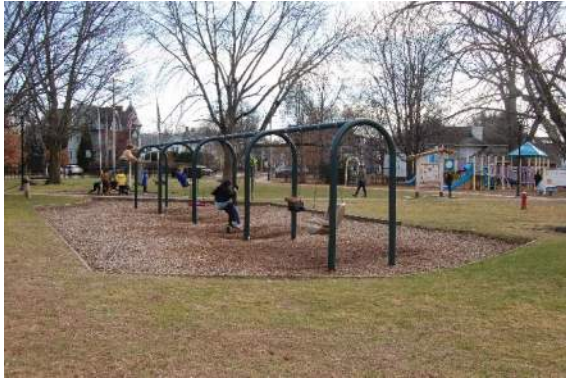
Photo 1: Swing Sets

- Modern Swings - 2 tot swings, 6 regular swings. Swings appear to be in good condition
- Fall zones appear to be adequate
- Modern Rocker/group Teeter Totter appears to be in good condition
- Park & play areas are immediately adjacent to Bridge Street School play facilities

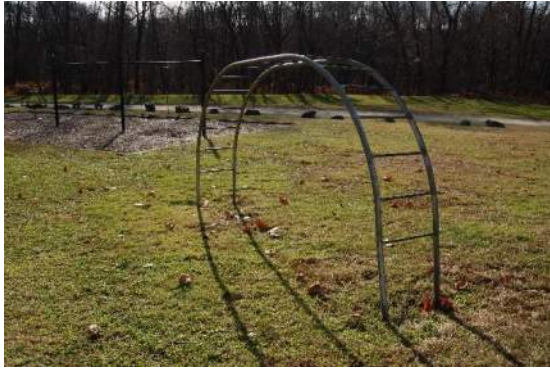
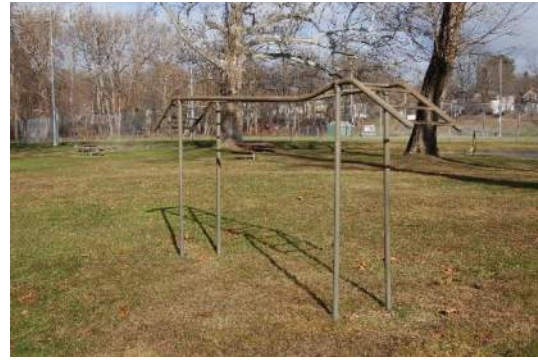
- Two climbing apparatus without any fall protection
- Play Area with 2 small spring toys, 1 rocker, 2 tot swings and 2 regular swings. All equipment in the play area appears to be in good condition.
- Fall zones appear to be adequate.
- Some weathering on the rocker apparatus.

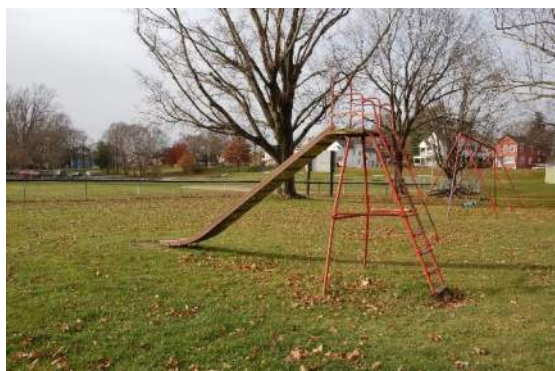
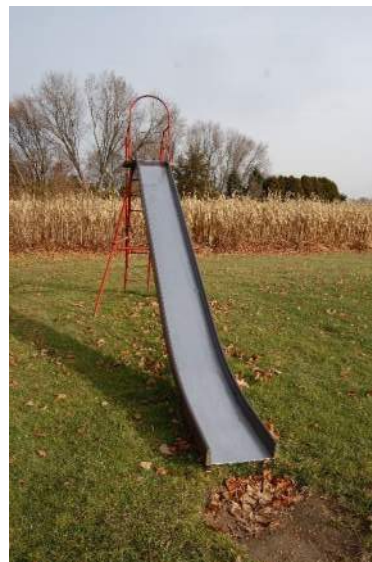
- Two apparatus without fall protection
- Exposed metal fasteners are a further hazard
- Metal Slide faces south and poses a hazard due to heat of the surface

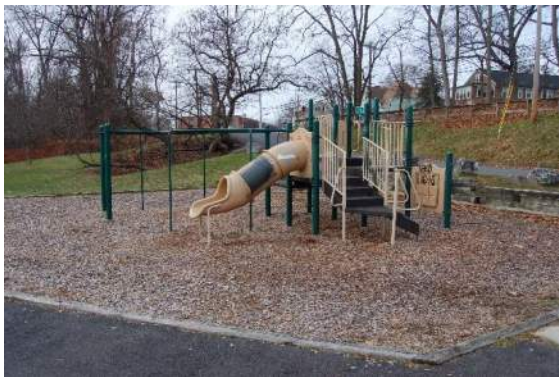
Photo 1: Play Structure

- Modern Play structure appears to have adequate fall zone protection
- Structure has some damage from vandalism
- Skate park and features appear to be in good condition

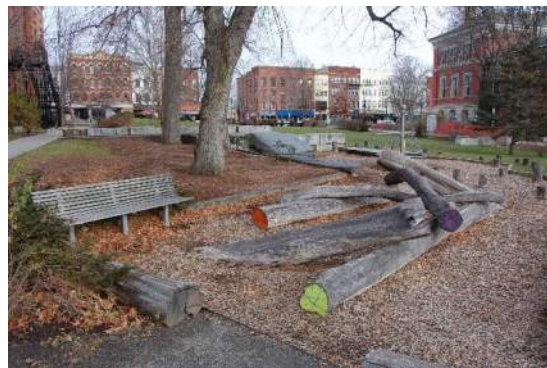
Photo 2: Log climbing structure

- Attractive downtown park with a custom play area. Equipment is in good condition
- Log climbing structure and spinner/climber appear to have adequate fall zone protection
- Ample seating provided for parents

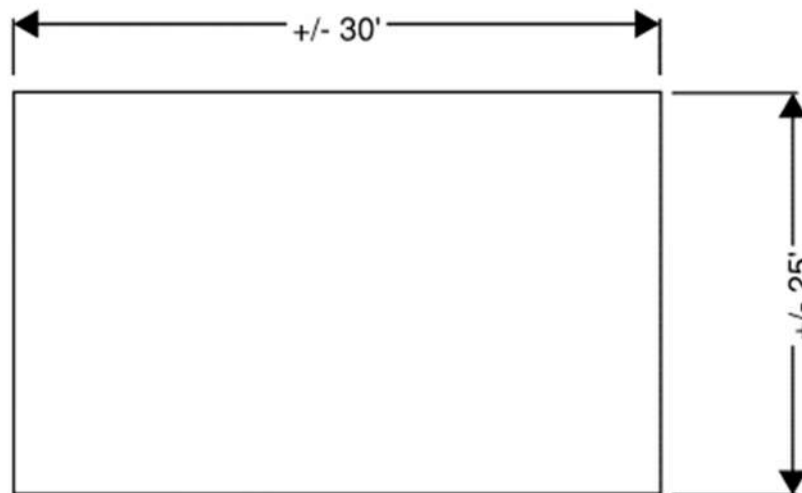
THE BUILDING CONTAINS A CONCESSION STAND WITH A SINK, REFRIGERATOR AND COUNTER SPACE, STORAGE SPACE, AND THREE BATHROOMS. THE DOOR SADDLES AT THE ENTRIES DO NOT MEET 521 CMR NOR ADA 2010, NOR DO THE CONCESSION OPENING HEIGHTS, CABINETS, ETC.

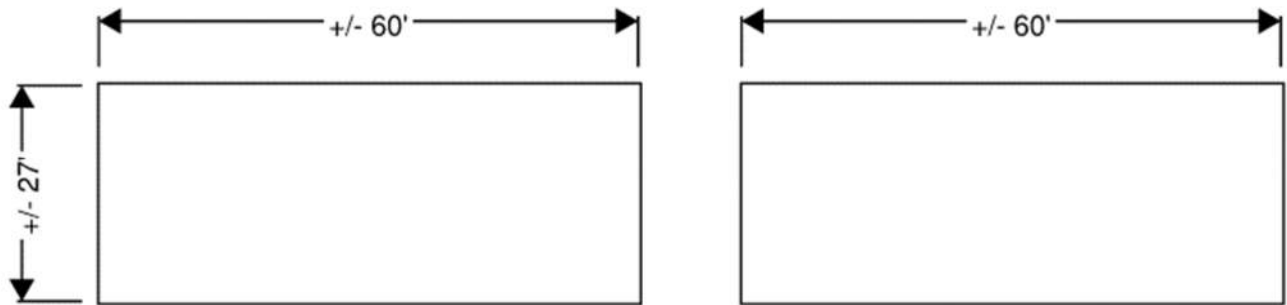
THE FACILITY CONSISTS OF TWO BUILDINGS OF SIMILAR SIZE AND DESIGN, WITH THE INTERIOR USES OF STORAGE SPACES, BATHROOMS, AND A COVERED OPEN AREA. THREE BATHROOMS ARE PROVIDED, WITH ONE UNISEX SERVING AS THE ACCESSIBLE BATHROOM. NO OBVIOUS ISSUES OBSERVED IN REGARD TO COMPLIANCE WITH 521 CMR AND ADA 2010.

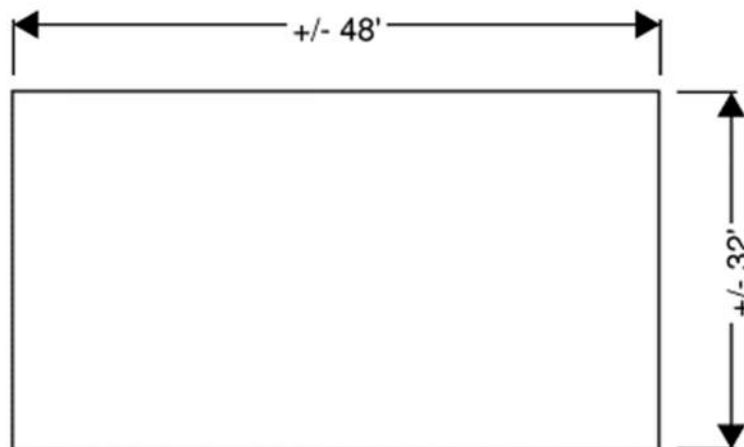
THE USES IN BUILDING CONSIST OF TWO BATHROOMS AND AN ELECTRICAL ROOM. NOTE THAT THE ELECTRICAL ROOM HAS HAD FLOODING WITHIN IT. THE BATHROOMS DO NOT MEET 521 CMR NOR ADA 2010. THE STRUCTURE WAS FLOODED TWICE IN 2023 AND IS IN VERY POOR CONDITION.

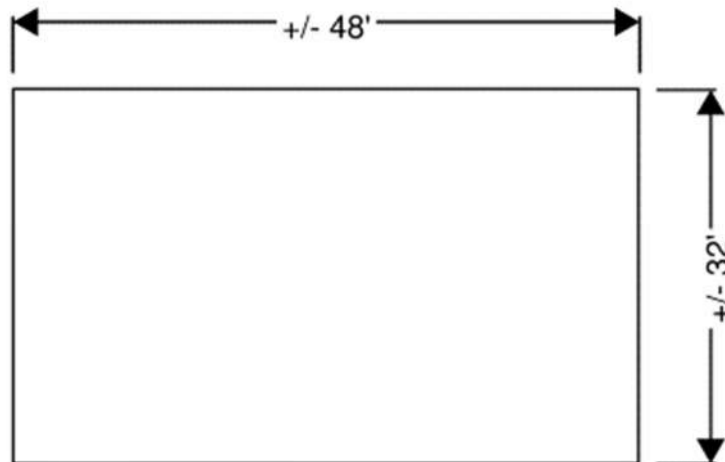
THE STRUCTURE SERVES AS AN OPEN-AIR PAVILION. IT WAS FLOODED TWICE IN 2023 AND IS VISIBLY WEATHERED WITH SIGNS OF BOWING IN BOTH THE ROOF STRUCTURE AND THE COLUMNS. THE BUILDING DOES NOT MEET 521 CMR NOR ADA 2010 AS IT DOES NOT HAVE AN ACCESSIBLE ROUTE TO THE STRUCTURE.

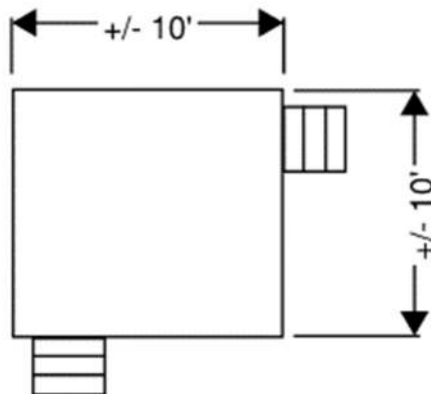
THE USE OF THE STRUCTURE IS AS A STORAGE SHED WHICH IS RAISED ABOVE THE GROUND AND ACCESSED BY WOODEN STEPS. THE STRUCTURE WAS FLOODED TWICE IN 2023 AND SHOWS VISIBLE SIGNS OF DETERIORATION. THE BUILDING DOES NOT MEET 521 CMR NOR ADA 2010 DUE TO THE ENTRIES NOT BEING AT GRADE AND ACCESSIBLE ONLY THROUGH WOODEN STEPS. THE WOODEN STEPS DO HAVE HANDRAILS.

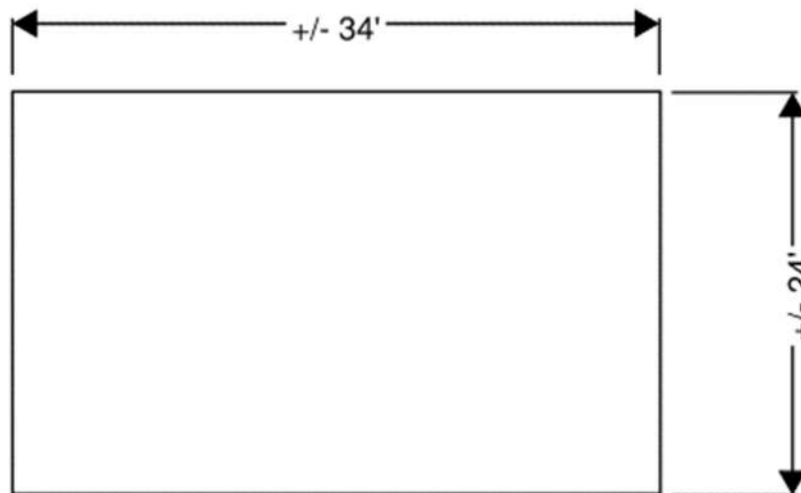
THE OVERALL CONDITION OF THE BUILDING FROM THE EXTERIOR IS GOOD. THE INTERIOR SHOWS PEELING PAINT ON THE WALLS AND FLOOR SLAB. THE BATHROOM PARTITIONS ARE IN POOR CONDITION. THE BUILDING DOES NOT SEEM MEET 521 CMR NOR ADA 2010 IN REGARD TO GRAB BAR DIMENSIONS AT THE TOILETS, EXPOSED PIPING AT THE UNDERSIDES OF THE SINKS, AS WELL AS NOT HAVING AN ACCESSIBLE ROUTE TO THE BUILDING ITSELF.

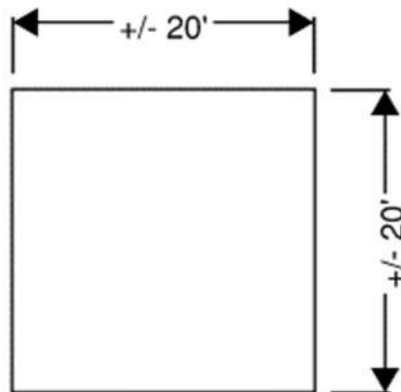
THE INTERIOR OF THE STRUCTURE WAS INACCESSIBLE. ONLY EXTERIOR OBSERVATIONS WERE MADE. PEELING GREEN PAINT ON THE EXTERIOR. OVERALL, THE BUILDING SEEMS TO BE IN POOR CONDITION. THE BUILDING DOES NOT MEET 521 CMR NOR ADA 2010 AT THE ENTRIES.

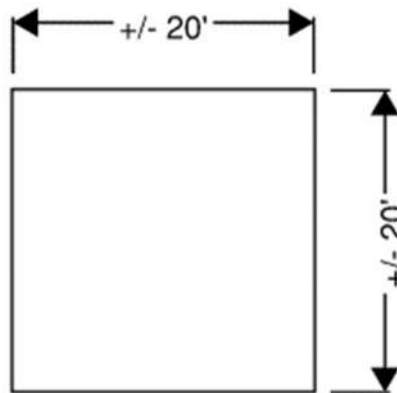
THE INTERIOR OF THE STRUCTURE WAS INACCESSIBLE. ONLY EXTERIOR OBSERVATIONS WERE ABLE TO BE MADE. THE EXTERIOR IS PAINTED WITH COLORFUL MURALS AND GRAFFITI. AN EXTERIOR DOOR IS BOARDED UP WITH PLYWOOD. WHETHER THE BUILDING MEETS 521 CMR OR ADA 2010 COULD NOT BE EVALUATED DUE TO THE BOARDING UP OF AN ENTRY WITH PLYWOOD AND NOT BEING ABLE TO ENTER INTO THE INTERIOR.
