Northampton Recreational Facilities Maintenance Report City of Northampton, MA

TO: Donna LaScaleia, Director of Public Works
FROM: Ryan Morrison PE, Project Manager, Tighe & Bond,
Zach Chornyak PE, Senior Project Manager, Tighe & Bond
DATE: July 2024

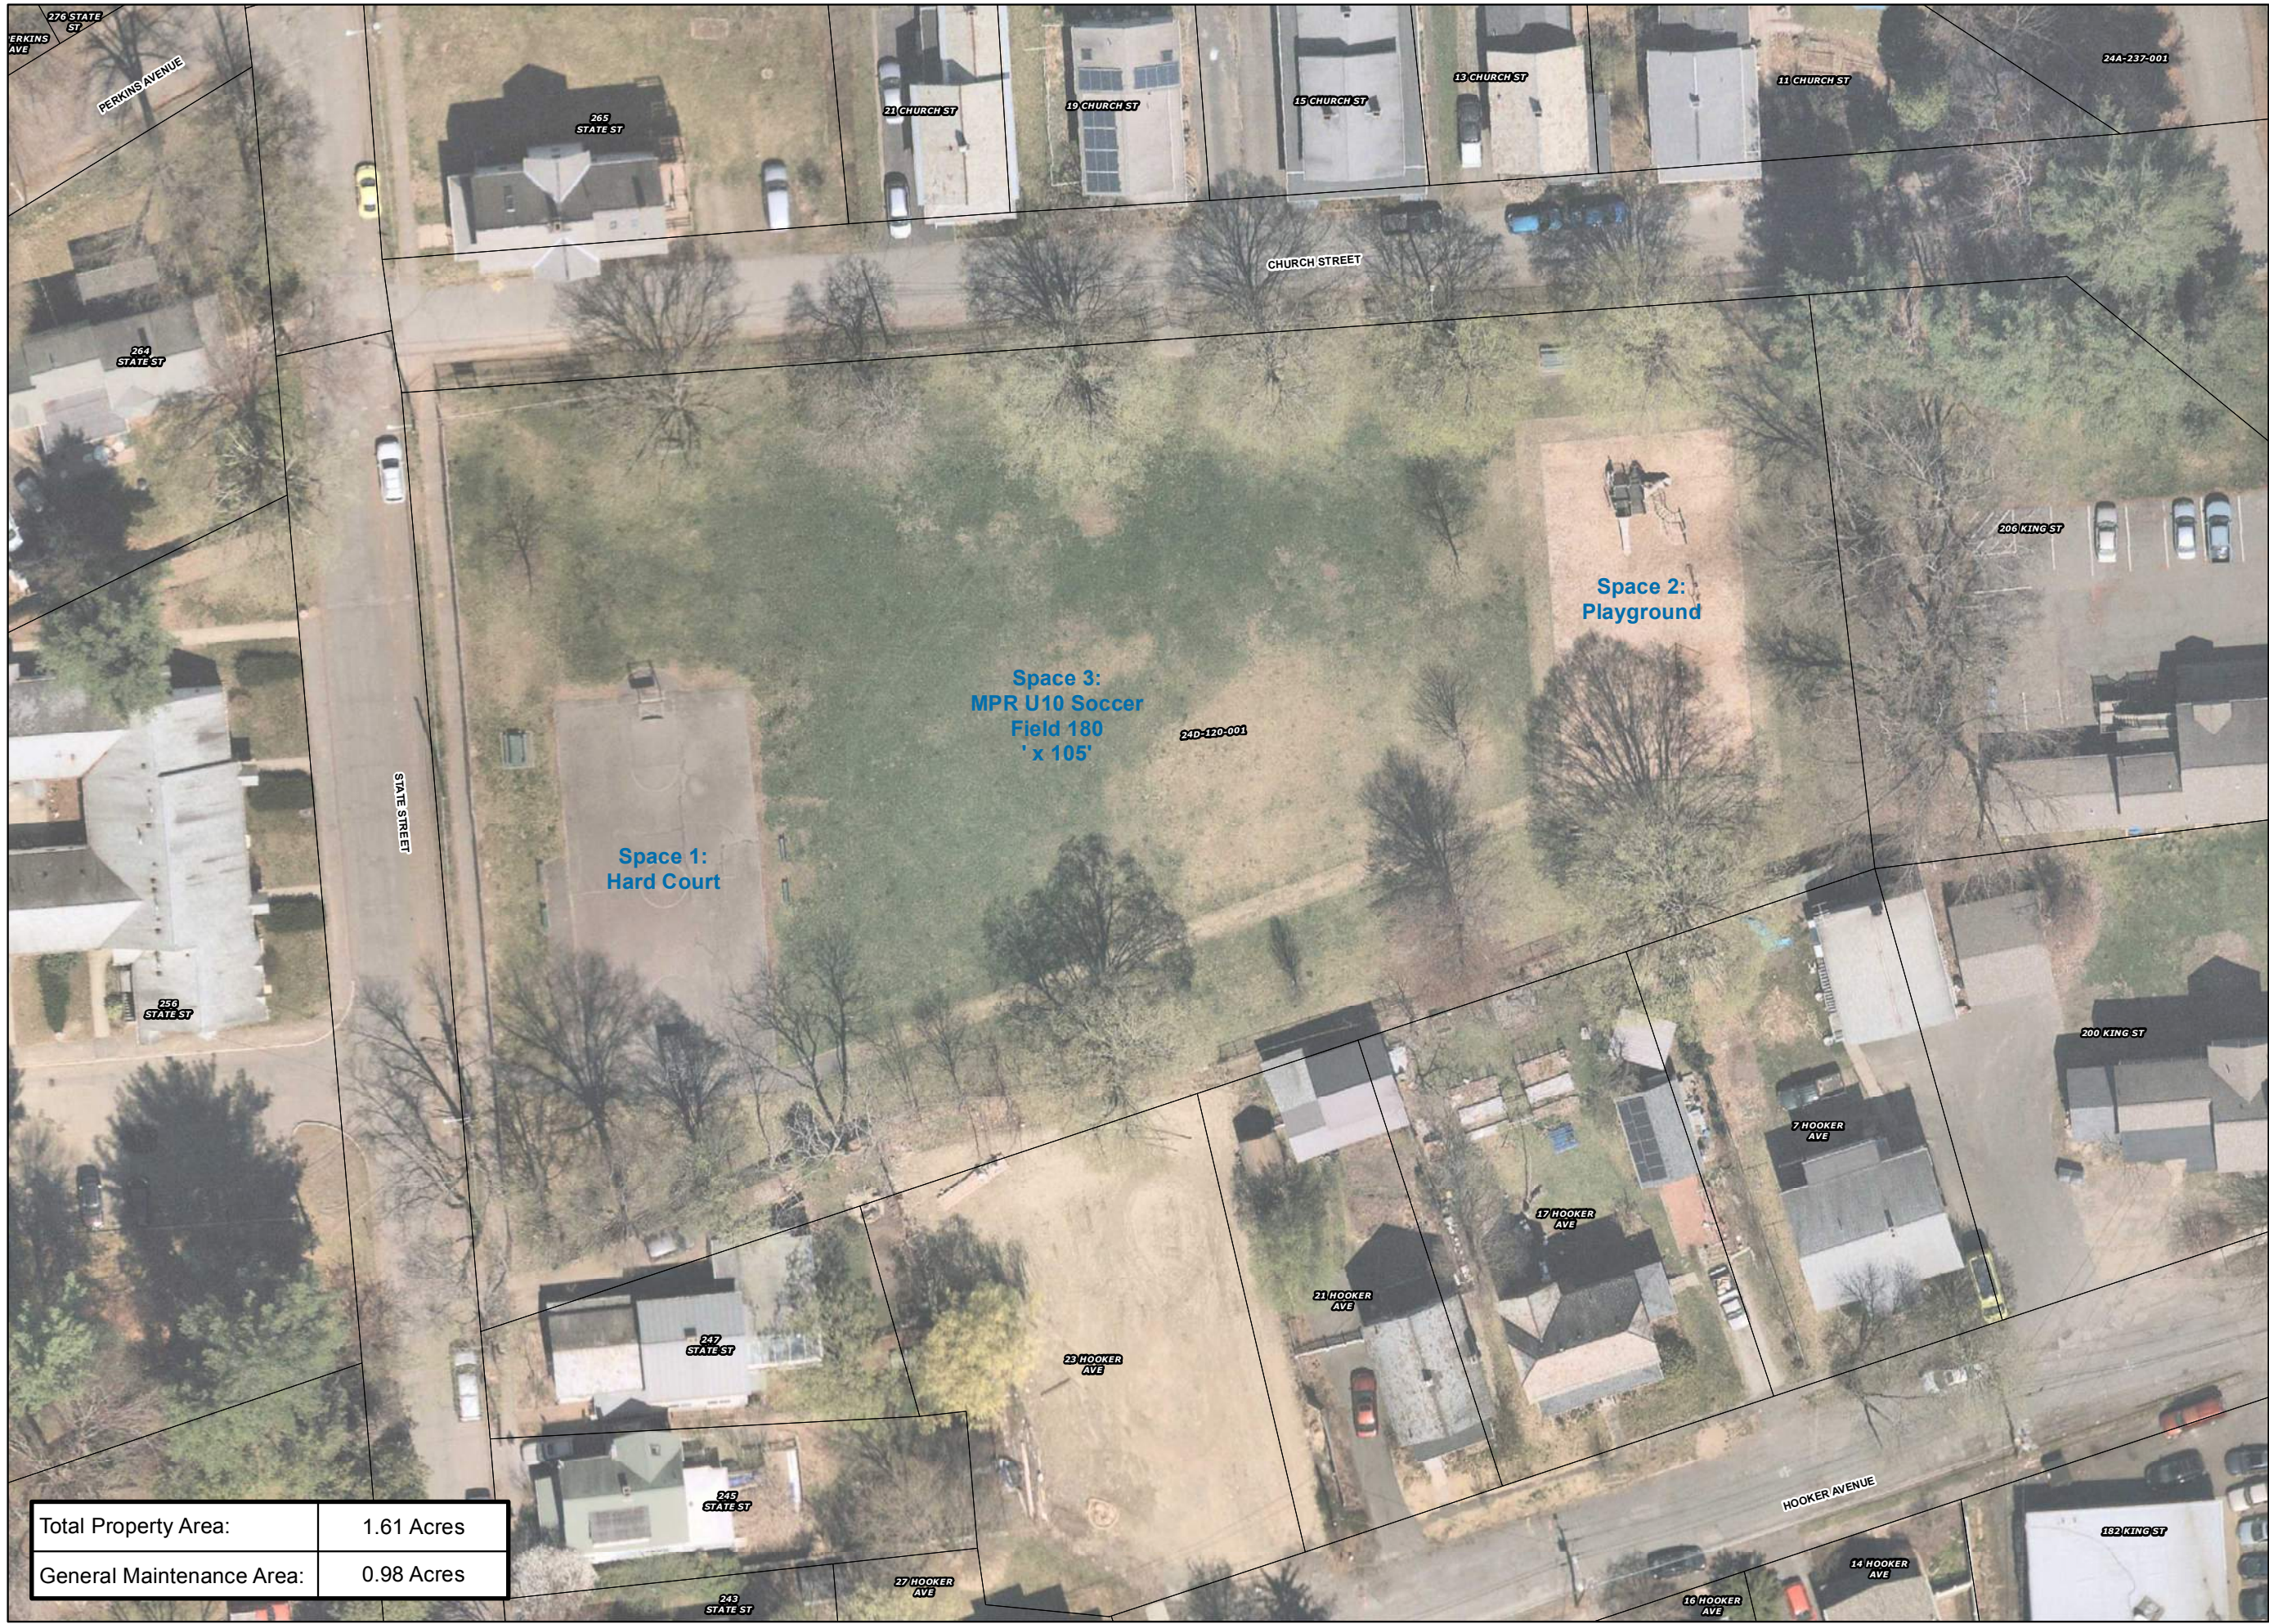
Figure 1
City of Northampton
Recreational Facility
Inventory

The 90-foot baseball diamond, denoted as "space 1" on the Arcanum Field Figure (Appendix B), was given a rating of 2.43. During a site visit the following was observed:

- First base and right field dimensions do not meet typical industry standards for 90-foot baseball diamonds.
- The turf in the outfield and infield skin are in poor condition. The turf has thin cover, and the infield skin has vegetation growth. The infield turf is in good condition.
- Minor areas of ponding were observed, indicating that adequate slopes are not being provided.
- Pitcher's mound and rubber is in poor condition with vegetive growth and holes. Backstop is in fair condition, but the plastic cover is not secure.
- Field is surrounded by chain-link fence along the backstop, seating areas, and dugout along first and third base. The chain-link fence is bent in some areas, including the dugouts, and has trees and brush growing under and through it.

The 60-foot baseball diamond, denoted as "space 2" (Appendix B), was given a rating of 2.57. During a site visit the following was observed:

- First base and right field dimensions do not meet typical industry standards for 60-foot baseball diamonds.
- Spectator seating, consisting of wooden bleacher, are in fair condition with some paint decay. Bleachers do not contain fall protection at the top.

The hard court was given a rating of 2.86. The court is denoted as "Space 3" in the Arcanum Field Figure (Appendix B). During a site visit the following was observed:

- Asphalt pavement is in fair condition, with some larger cracks greater than 1 inch and vegetative growth.
- The support posts of the backboard are in fair condition and rusted.

The concession building with restrooms is denoted as "Space 4" on the Arcanum Field Figure (Appendix B). During a site visit the following was observed:

- The wooden stairs outside of the building are in poor condition, showing signs of wear. The stairs do not have a handrail, which does not comply with building code regulations.

- The interior walls of the building are in poor condition. There are areas of wallboard that are missing, leaving the framing of the building exposed. The interior painting is in poor condition and peeling.
- The door saddles at the entrance to the building, concession opening heights and cabinetry do not meet 521 CMR standards or ADA 2010 Accessibility standards.

The playground is located directly east of the parking lot and is denoted as "Space 5" on the Arcanum Field Figure (Appendix B). During a site visit the following was observed:

- Playground equipment is in good condition, but one standard swing is missing.

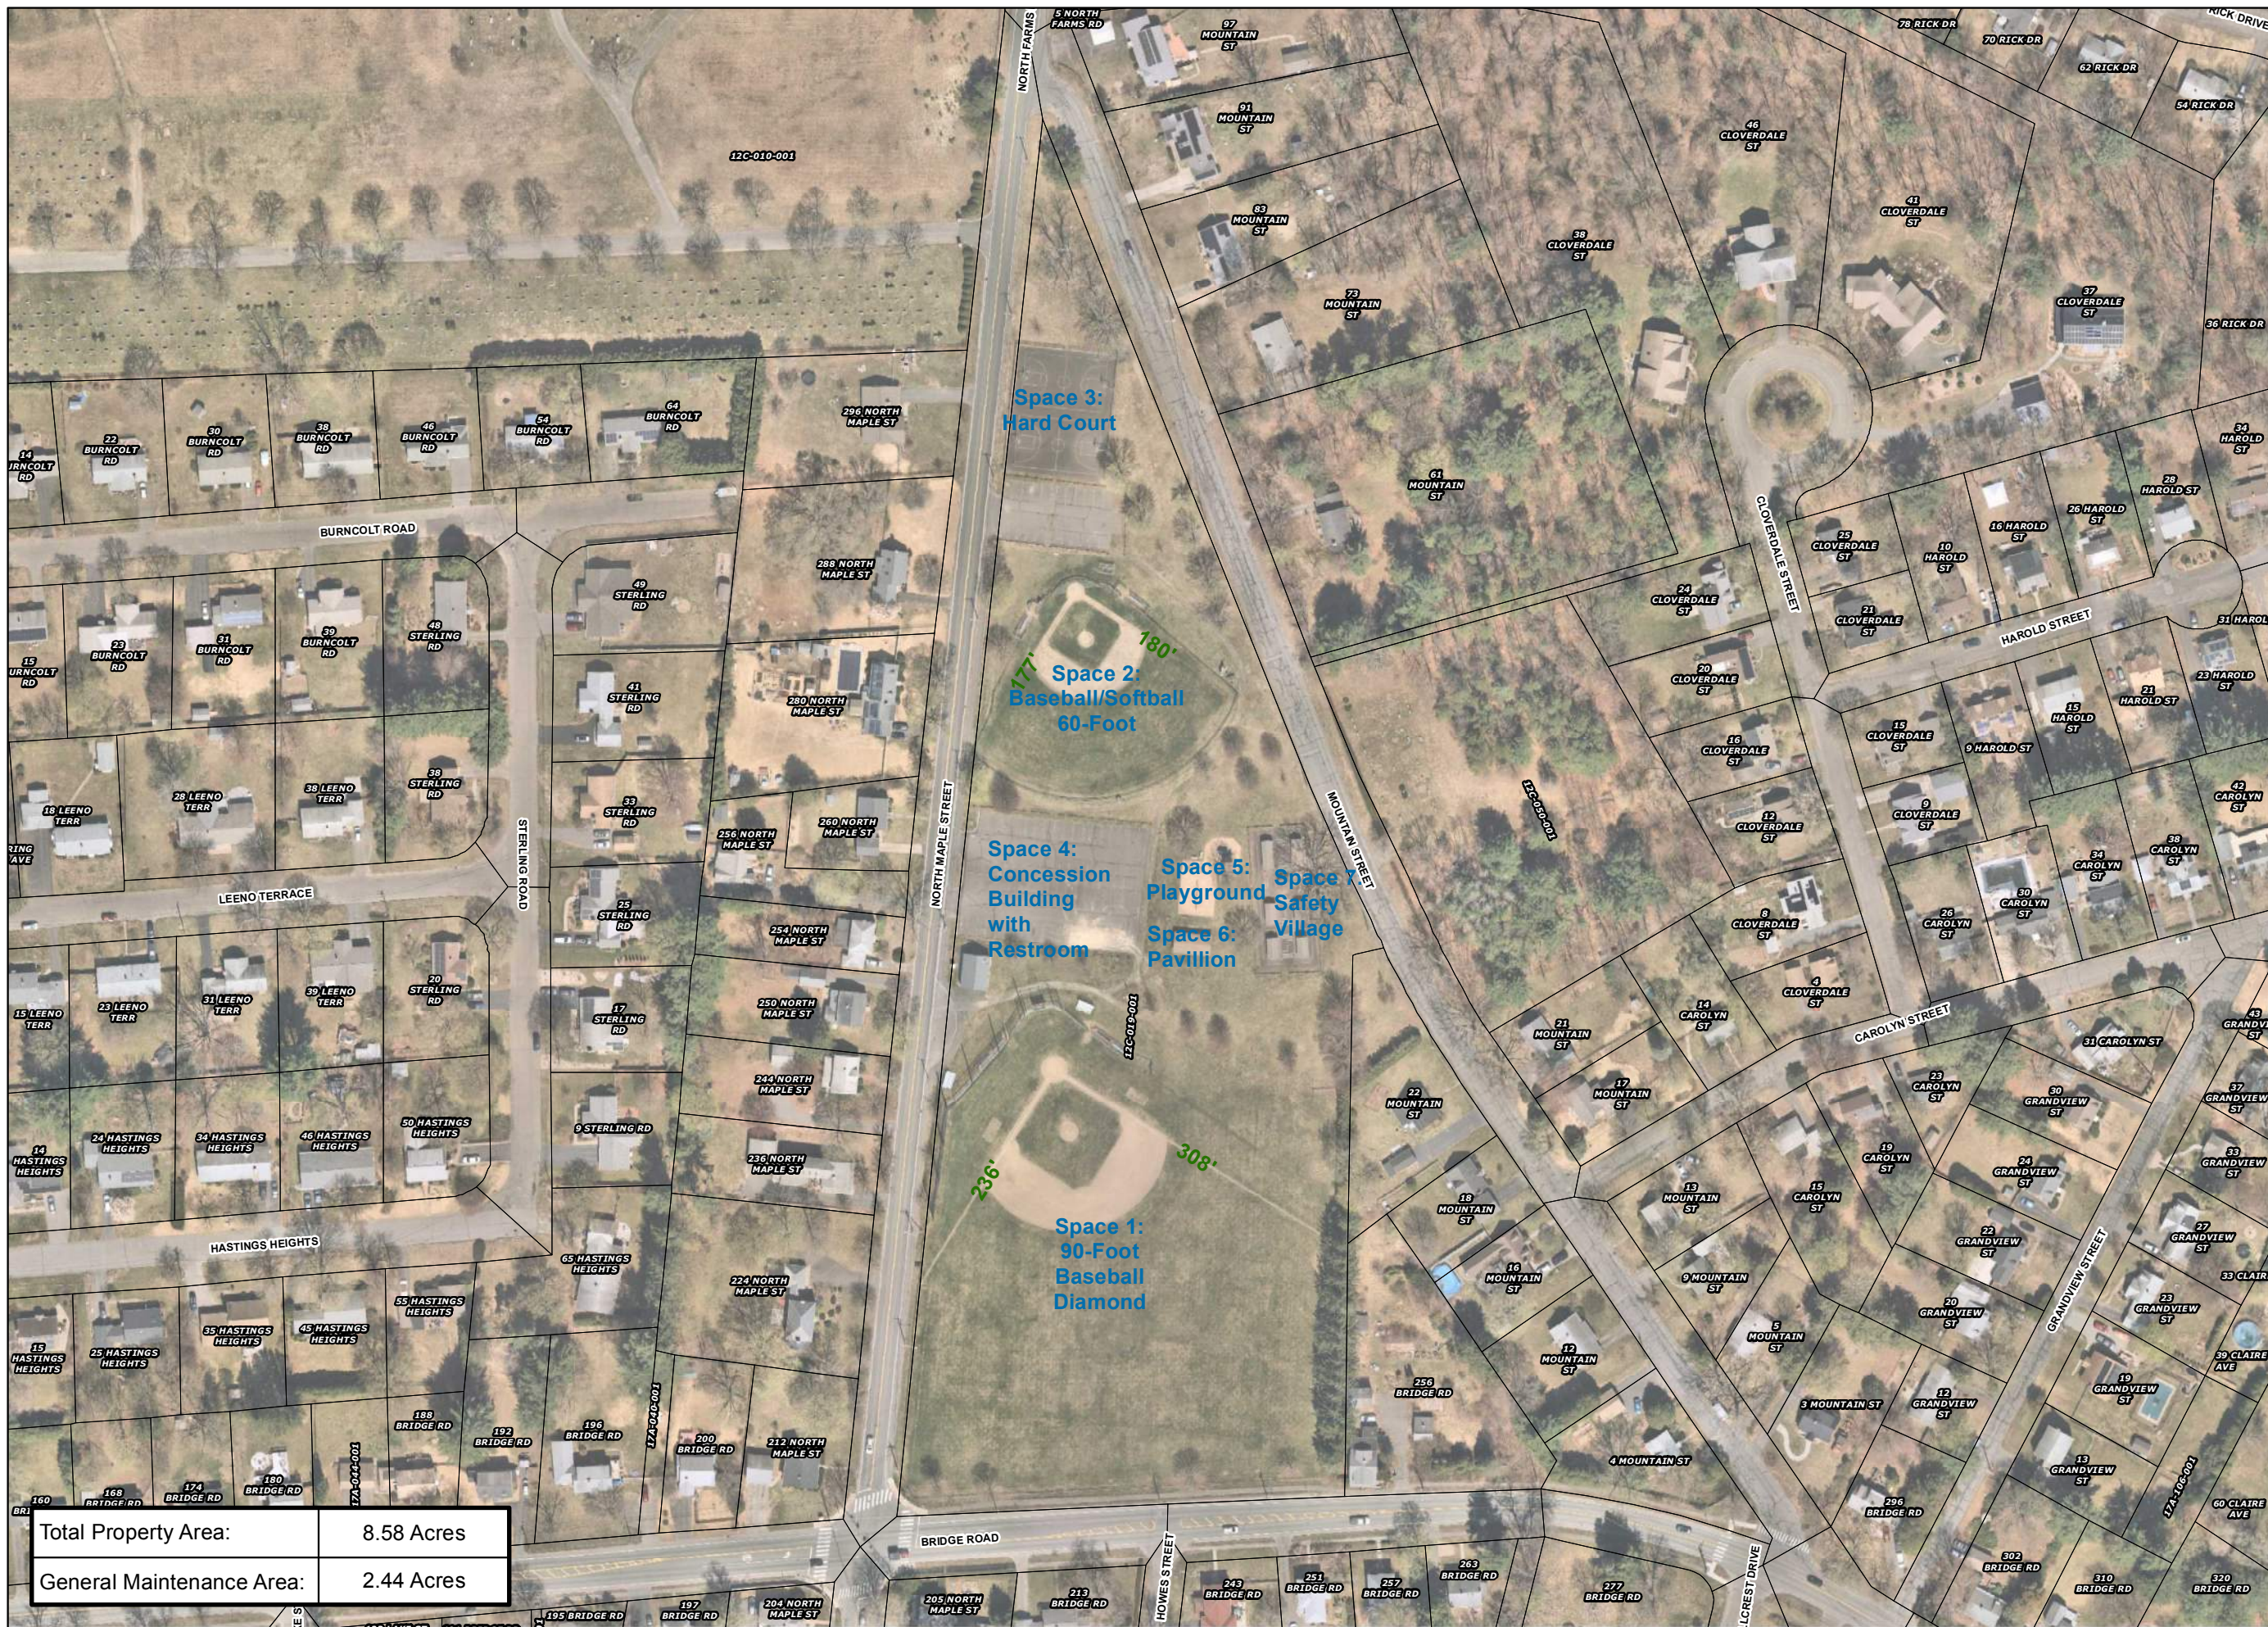
Figure 3
City of Northampton
Recreational Facility
Inventory

The hard court, denoted as "Space 1" on the Agnes Fox Playground Figure (Appendix B), was given a rating of 2.1. During a site visit, the following was observed:

- Court's asphalt surface is in poor condition, with cracks and vegetative growth. The uneven level of the asphalt surface raises concern for potential safety issues.
- Backboards, hoops, and nets show signs of extended wear. Portions of the support poles and joints are rusted and are not level.

The playground is on the eastern edge of the facility and is denoted as "Space 2" in the Agnes Fox Playground Figure (Appendix B). During a site visit, the following was observed:

- The exposed foundation of the tot swing is in poor condition and raises concern for a potential hazard.
- Site has poor drainage, as the wood fiber surface is wet.

It is recommended that drainage infrastructure is upgraded on site, as wet surfaces lessen the optimal life of wood fiber, creating an uneven surface from rotting.

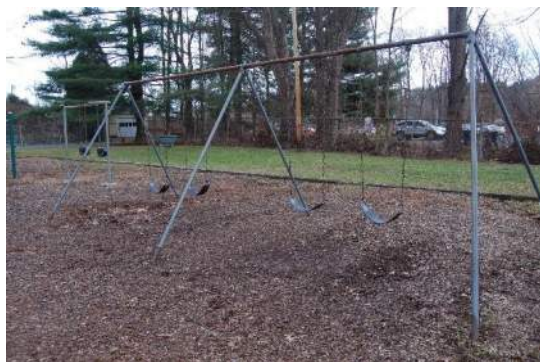
Photo 5: Swing

- The primary play structure is in good condition, fall zones appear to be adequate.
- The 2-bay tot swing apparatus is in poor condition with an exposed foundation that creates a potential hazard.
- The four swings are in fair condition. The apparatus is old and shows signs of degradation.
- The roller/climber is in good condition
- The wood fiber surface is very wet, indicating poor drainage. This condition leads to shorter than optimal life of the wood fiber, unevenness of the surface and potential subsidence of the resilient surface due to rotting of the wood fiber.

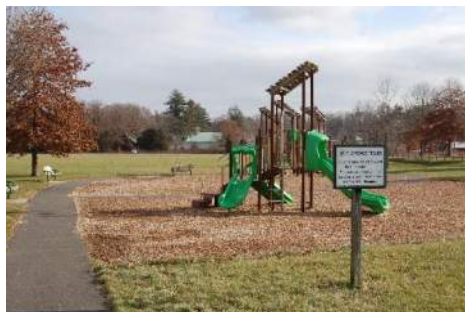
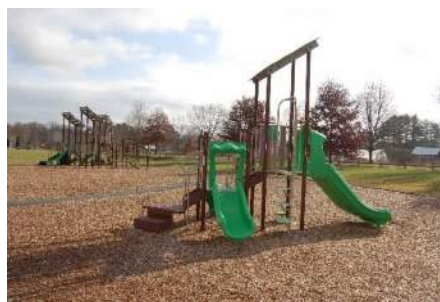
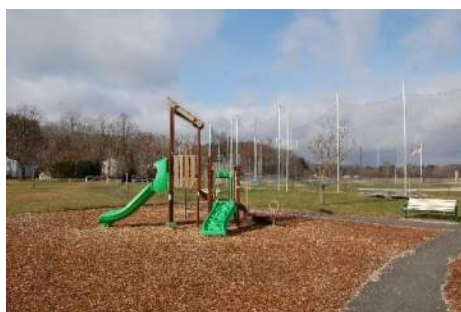
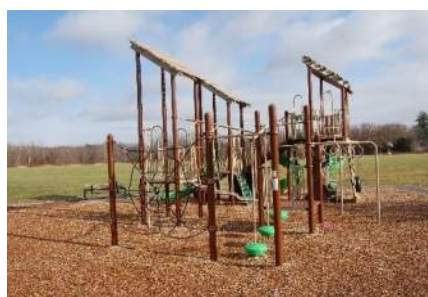
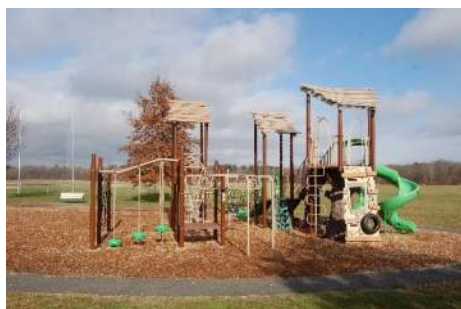
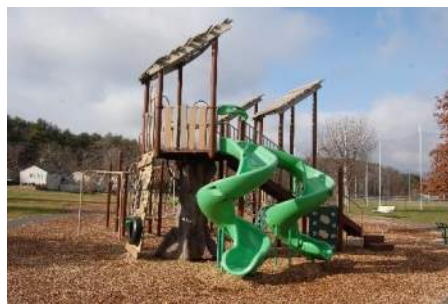
- Modern play structures for 3-5 year olds and 6 to 12 year olds
- It appears that the implementation of play areas has been phased, with a fairly large “blank” area between the two structures. Fall zones appear to be adequate
- Several benches have been provided for parents

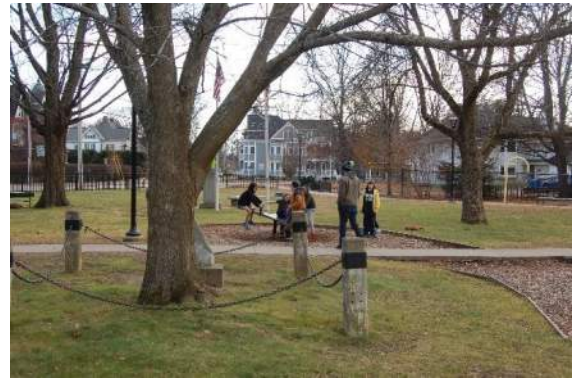
Photo 2: Rocker/group Teeter-totter

- Modern Swings - 2 tot swings, 6 regular swings. Swings appear to be in good condition
- Fall zones appear to be adequate
- Modern Rocker/group Teeter Totter appears to be in good condition
- Park & play areas are immediately adjacent to Bridge Street School play facilities

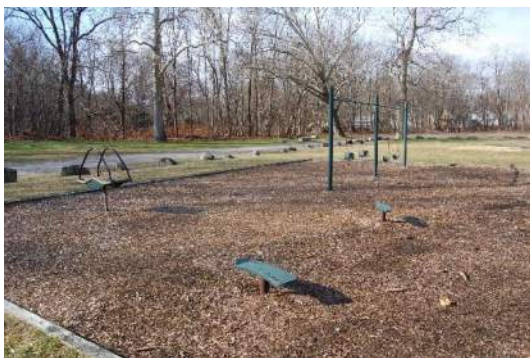
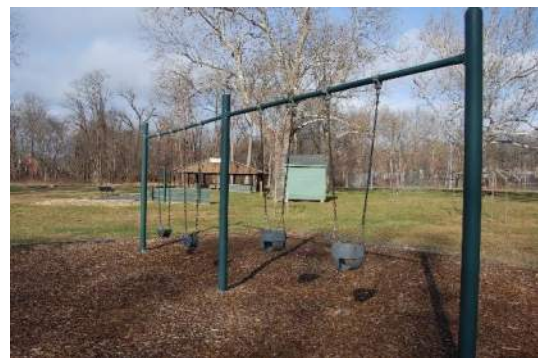
- Two climbing apparatus without any fall protection
- Play Area with 2 small spring toys, 1 rocker, 2 tot swings and 2 regular swings. All equipment in the play area appears to be in good condition.
- Fall zones appear to be adequate.
- Some weathering on the rocker apparatus.

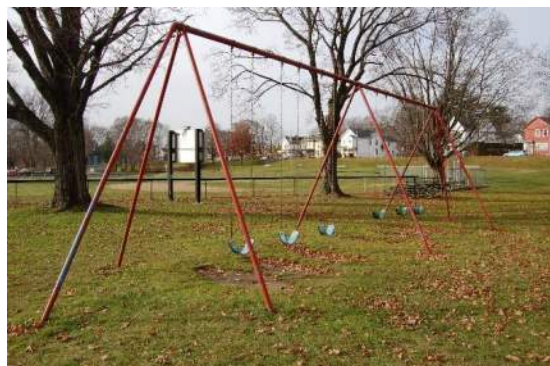
Photo 3: Swings

- Two apparatus without fall protection
- Exposed metal fasteners are a further hazard
- Metal Slide faces south and poses a hazard due to heat of the surface

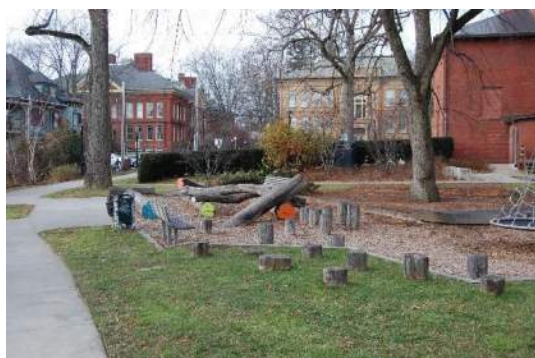
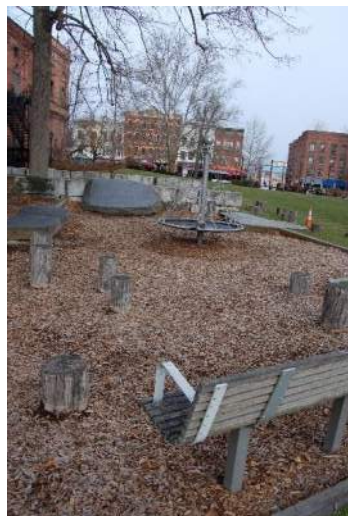
- Attractive downtown park with a custom play area. Equipment is in good condition
- Log climbing structure and spinner/climber appear to have adequate fall zone protection
- Ample seating provided for parents
